Manhole Inspection Summary

Manhole # S4300_017MH

Insp Date: **12/14/07 10:37 AM**

Location Address: **Cliftview Ave**

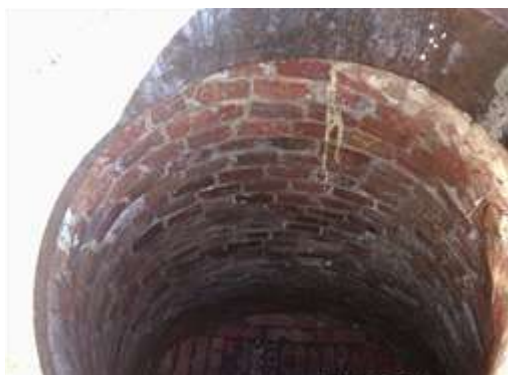
Defect 1

Infiltration: ☐ None ☒ **Joint** ☐ Cracks ☐ Mortar ☐ Roots ☐ Wall

Infiltration: ☐ None ☐ Joint ☐ Cracks ☐ Mortar ☐ Roots ☒ **Wall**

Infiltration

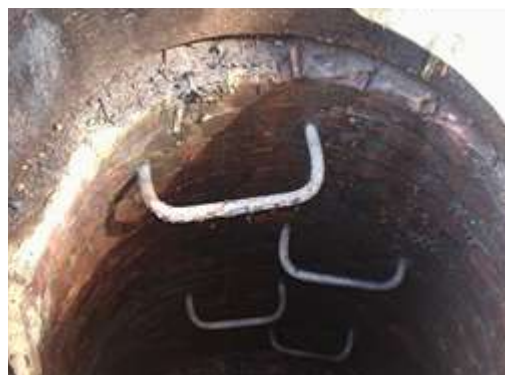
Defect 2

Frame Offset: **2** (in.) Condition: ☐ Sound ☐ Cracked ☒ **Leaks**

Frame leaks

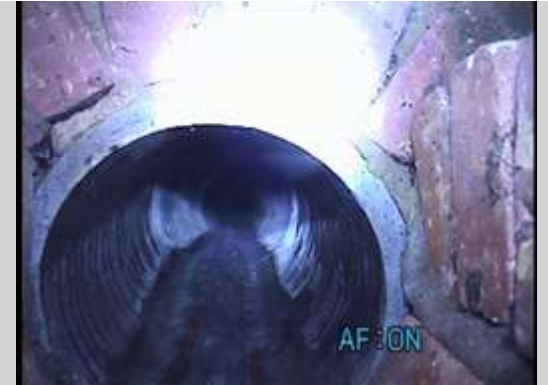
12 O'Clock Outflow

8 in. Circular Gravity Sewer
Pipe Out @ 12 O'Clock

Pipe Height: **8.4** (in.) Rod and Bar (Angled)
Pipe Material: **Clay** ☐ Pipe Lined
Invert Depth: **8.26** (ft.) Flow Characteristics: **Fast**
Deposits: ☒ None ☐ Mud ☐ Sludge ☐ Debris ☐ Grease
Silt Depth: (in.) Deposits Extent:
Infiltration: **None** Pipe Seal Cond: **Sound**

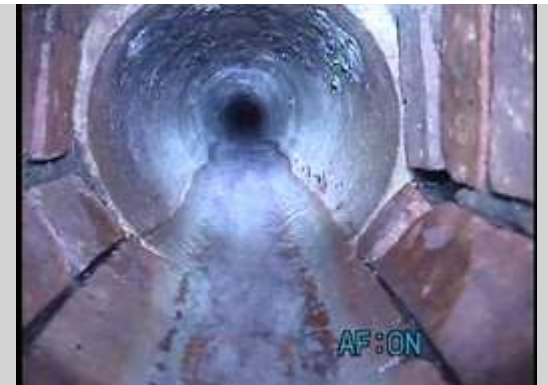
5 O'Clock Inflow

8 in. Circular Gravity Sewer
Pipe In @ 6 O'Clock

Pipe Height: **8.4** (in.) Rod and Bar (Angled)
Pipe Material: **Clay** ☐ Pipe Lined
Invert Depth: **7.99** (ft.) Flow Characteristics: **Fast**
Deposits: ☒ None ☐ Mud ☐ Sludge ☐ Debris ☐ Grease
Silt Depth: (in.) Deposits Extent:
Infiltration: **None** Pipe Seal Cond: **Sound**
